Moenjodaro: A World Heritage Site at Risk

Muhammad Safdar Khan

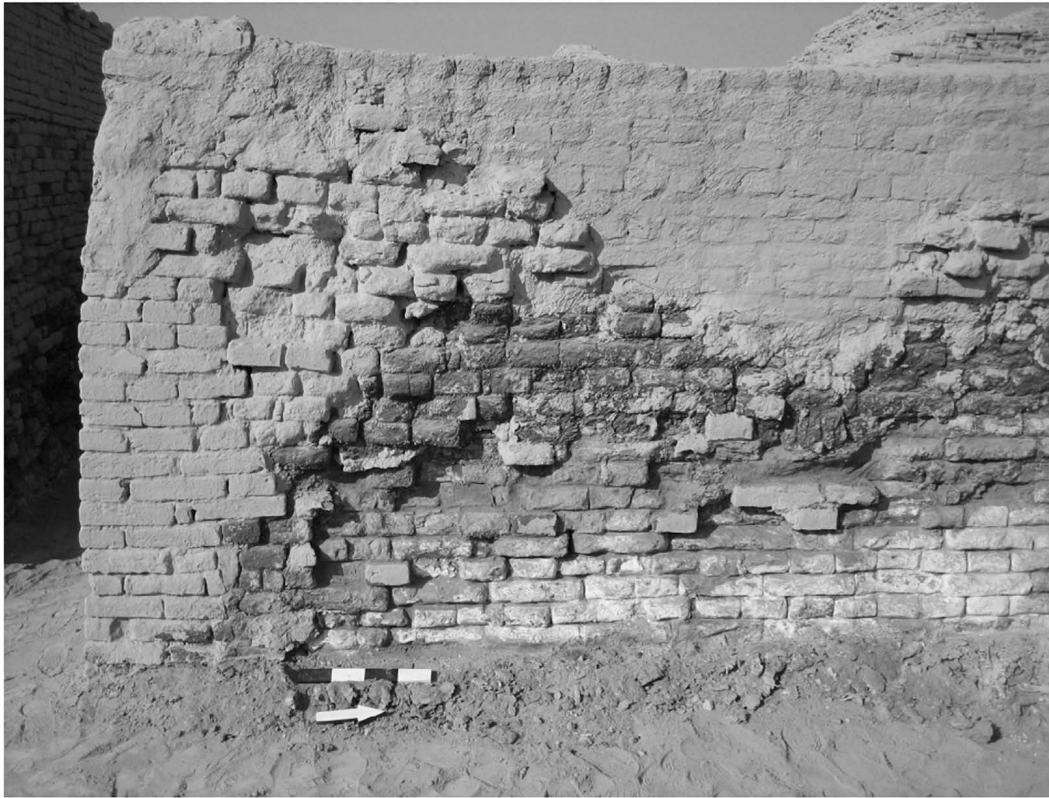
- i. Subsoil water is driven upwards by capillary action through the structures and in so doing it carries soluble salts. Such salts effloresce on the brick surface if the evaporation is slow, and sub-florescence if the evaporation is fast (Figures 3 and 4).
- ii. Hygroscopic salts such as sodium sulphate draw water from the air and are put in solution. Phenomena of hydration and dehydration occur because of temperature cycles, and this creates great pressure for both brick and mortar that tend to powder. If the evaporation is slow not only powdering takes place, but also chunks of bricks fall apart.

During the winter, salts tend to crystallize mainly on the northern and western elevations and sometimes on the eastern faces when in shade because the favorable temperature for crystallization is 32 °C. In the summer the phenomenon takes place within the brick fabric with the result that masonry tends to spall (subflorescence). Mud slurry is the best remedy for protecting bricks from decay caused by efflorescence. Furthermore, mud plaster is effective against subflorescence as it can minimize heating of the structures to some extent. The data provided in Table 1 shows that the most common salts are sodium, potassium, calcium, magnesium, carbonate, bi-carbonate, nitrate, nitrite, chloride and sulphate, with sodium sulphate and sodium chloride found in abundance. The analysis further shows that the amount of salts decreases with the increase in depth, and this is suggested by the fact that their concentration is higher at the surface due to evaporation.

Figure 3: Moenjodaro, Soluble salts attack at main street, DK-G area.

- iii. Mud poulticing and mud slurring is essential for overcoming the problem of salts as crystallization occurs on the sacrificial coat rather than on the brick face (Khan 1993). However, it is essential that a monitoring system is developed and carried out.

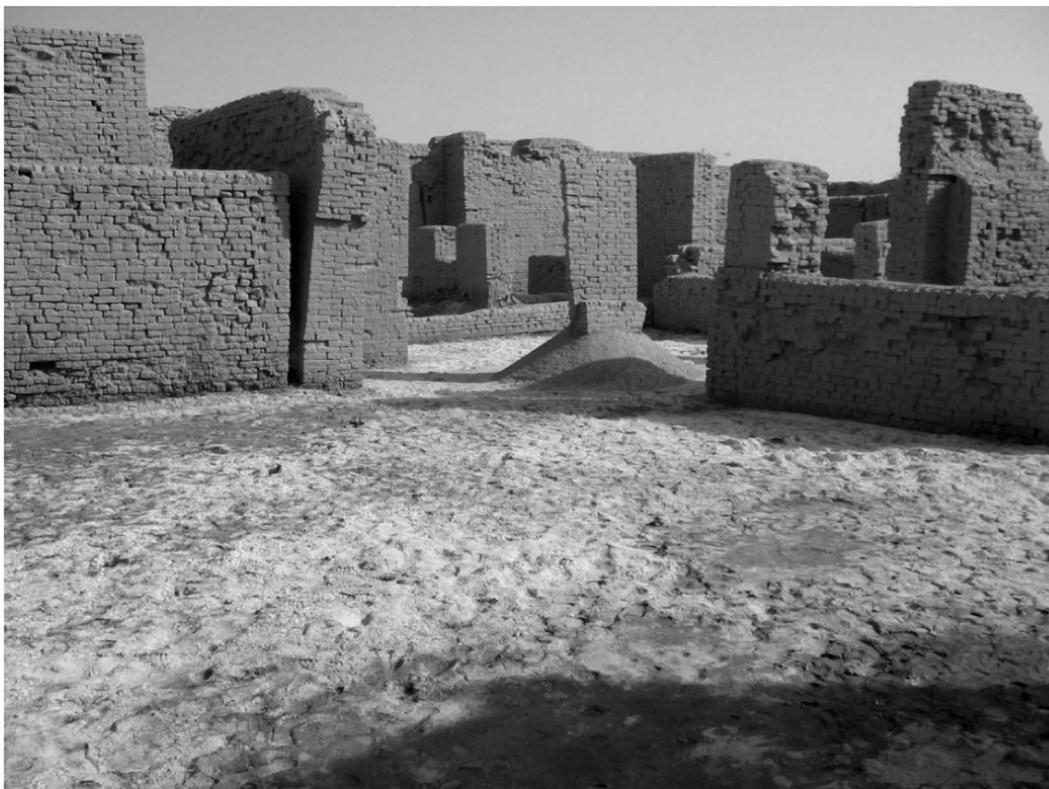
Figure 4: Moenjodaro, Picture showing DK-G area with salts affected soil.

- v. Repointing is carried out not as cosmetic measure, but for consolidating those structures that lack of bonding.
- vi. Improvement of drainage and replacement of salt affected soil. The second is necessary to reduce the extent to which ground salts affect the structures through capillary rise.

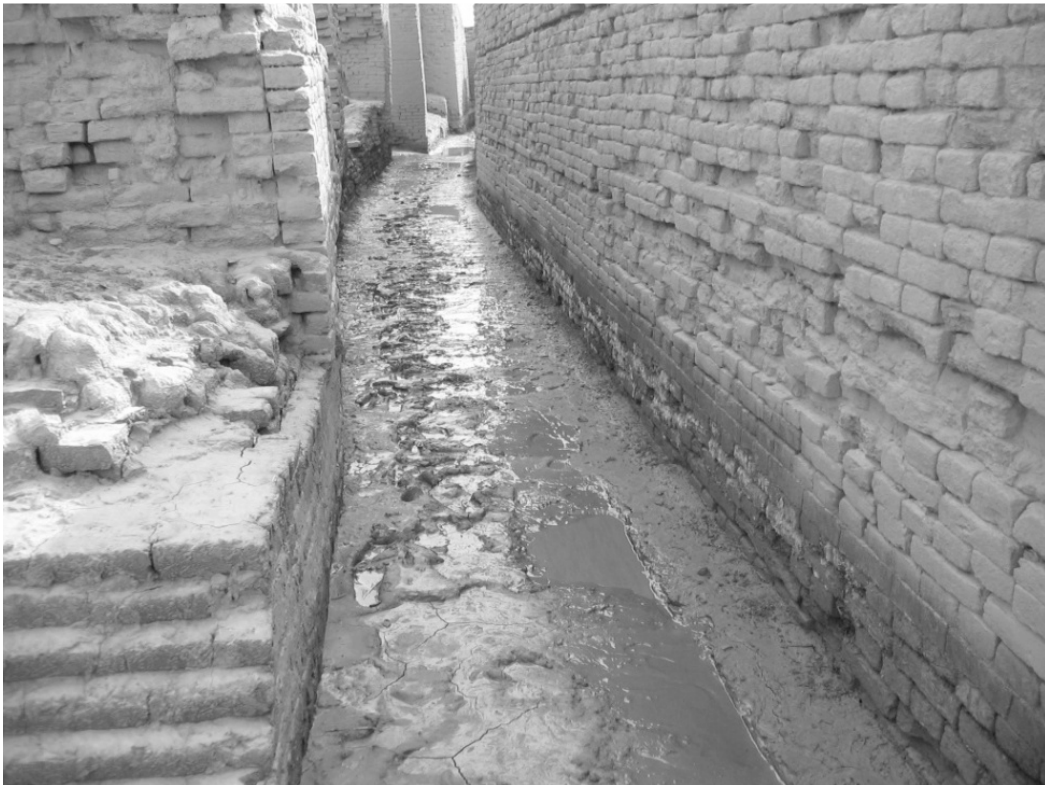
Monsoon rain is one of the main causes of masonry decay. Fired brick structures tend to be eroded and settle when precipitation is combined with poor drainage (Figure 5). Precipitation concerns the structures at two levels. The erosion of mud mortar, mud brick capping, and fired brick masonry is deeper in the top portion. The lower portion is affected by ponding due to water mismanagement, contributing towards the rising of dampness. Rainwater mostly affects the site from the north and it should also be mentioned that splashing plays a role in the decay of mud mortar. Due to the topography of Moenjodaro's excavations it is quite complicated to drain out water from the site. However, the effort made by MCRC in 2005 proved to be effective and drainage was improved in several areas. Proper topographic survey is essential for the recovery of drainage system, and this is still to be carried out in Moenjodaro. Water needs to be drained slowly as fast drainage causes gullies and holes. In this sense the employment of barriers of sun-dried bricks proved to be effective for the slowing down of rainwater flow.

Figure 5: Moenjodaro, Water ponding after monsoon rain, DK-G area.
