# Landslide hazard zonation map of Kurram Valley: A case study of landslide at Gharbina village, Parachinar, Kurram Valley

### Abstract

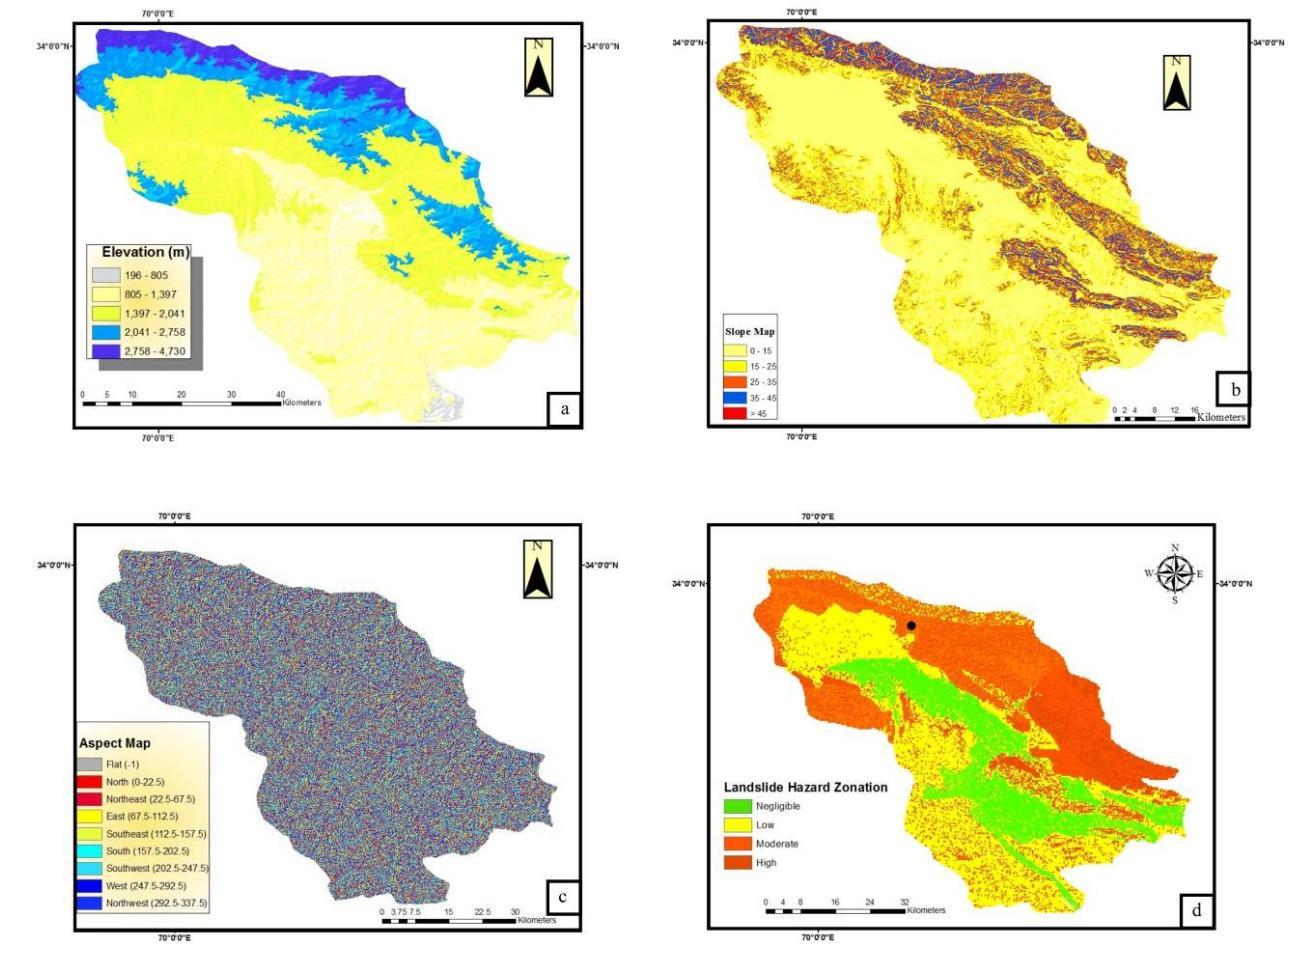
Fig. 1a) Digital elevation model of entire Kurram valley. (b) Slope map of Kurram valley. (c) Aspect map of Kurram valley. (d) Landslide hazard zonation of entire Kurram valley. Black circle showing case study area (Gharbina village).

Detail landslide hazard zonation map of Kurram valley was prepared by combining the data from layers mentioned above (Fig. 1d). The valley is classified into four classes named negligible, low, moderate and high hazard areas. According to final landslide hazard zonation, the case study area lies in the high risk region within the Kurram valley.

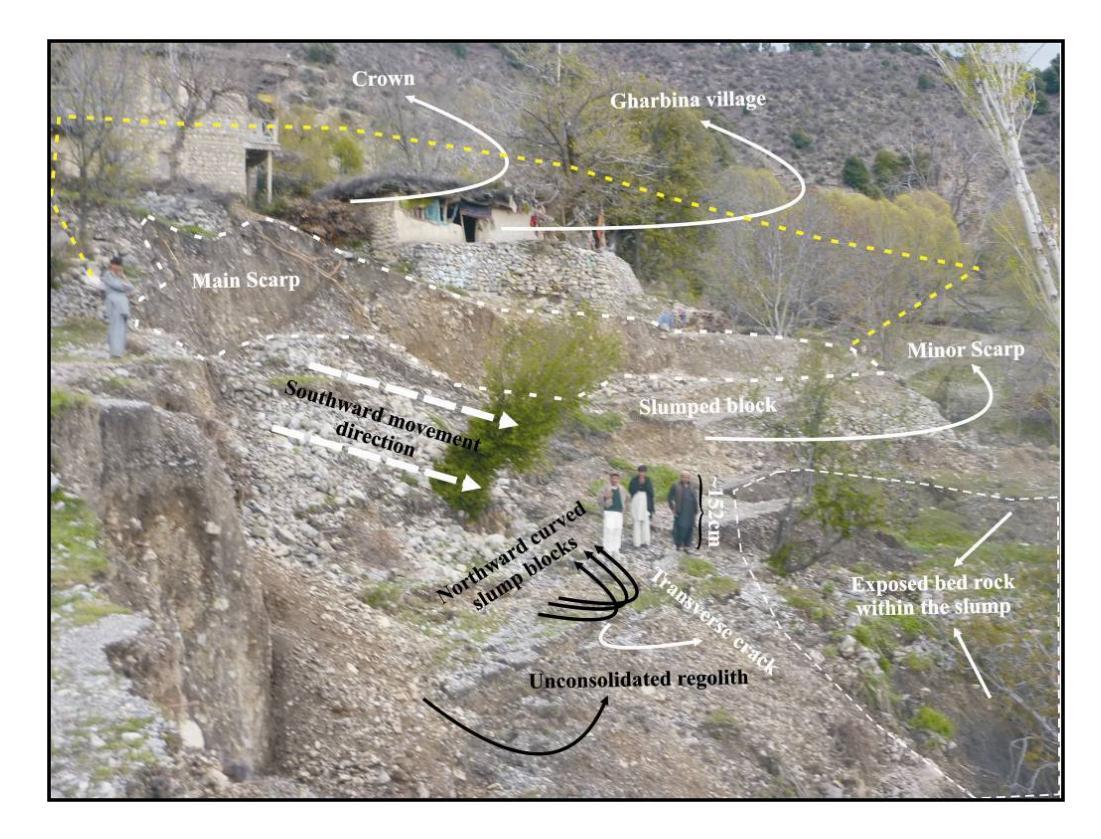
The elevation difference between the crown and toe of the slump is approximately 563 m. The structural anatomy of the Gharbina slump consists of well-developed crown, scarp, bed rock, toe, slip plane and rubble. The main scarp shown in Figure 2, has the maximum width at the foot point of the scarp, where the debris are maximum and decreases further towards the exposed bedrock. The main movement of the slumped block is towards south, while the block has been rotated northward. The slumped block has been divided into numerous sub scarps, which expose bedrocks within the block. The vertical length of the scarps is gradually decreases towards south. The rotational slump has been taken place along a clay-bed slope, which is concealed by regolith derived from the surrounding mountains. The event had badly affected wheat crops, orchards, poplar and walnut trees, which were the only living, sources of income in the region (Fig. 3a-d). It had also disrupted 118 m road connecting Gharbina, Khachan, Dand and Rajju villages to Parachinar city (Fig. 3e). Walls of the houses at Gharbina village were cracked, which have potential for future hazards (Fig. 3f).

Fig. 2. Photograph showing main scarp of the Gharbina slump, which is  $\sim 0.5$  meter from residential area. Key morphological features of the slump are shown on the photograph.

Slump scarps facing downslope direction are the vertical exposures of the transverse cracks (Fig. 2). Major and minor scarps in the area are predominantly east-west trending. The main scarp of the slump has about 8.3 feet height. These scarps are fresh and unvegetated. It is interpreted that they are very recently developed in the area.

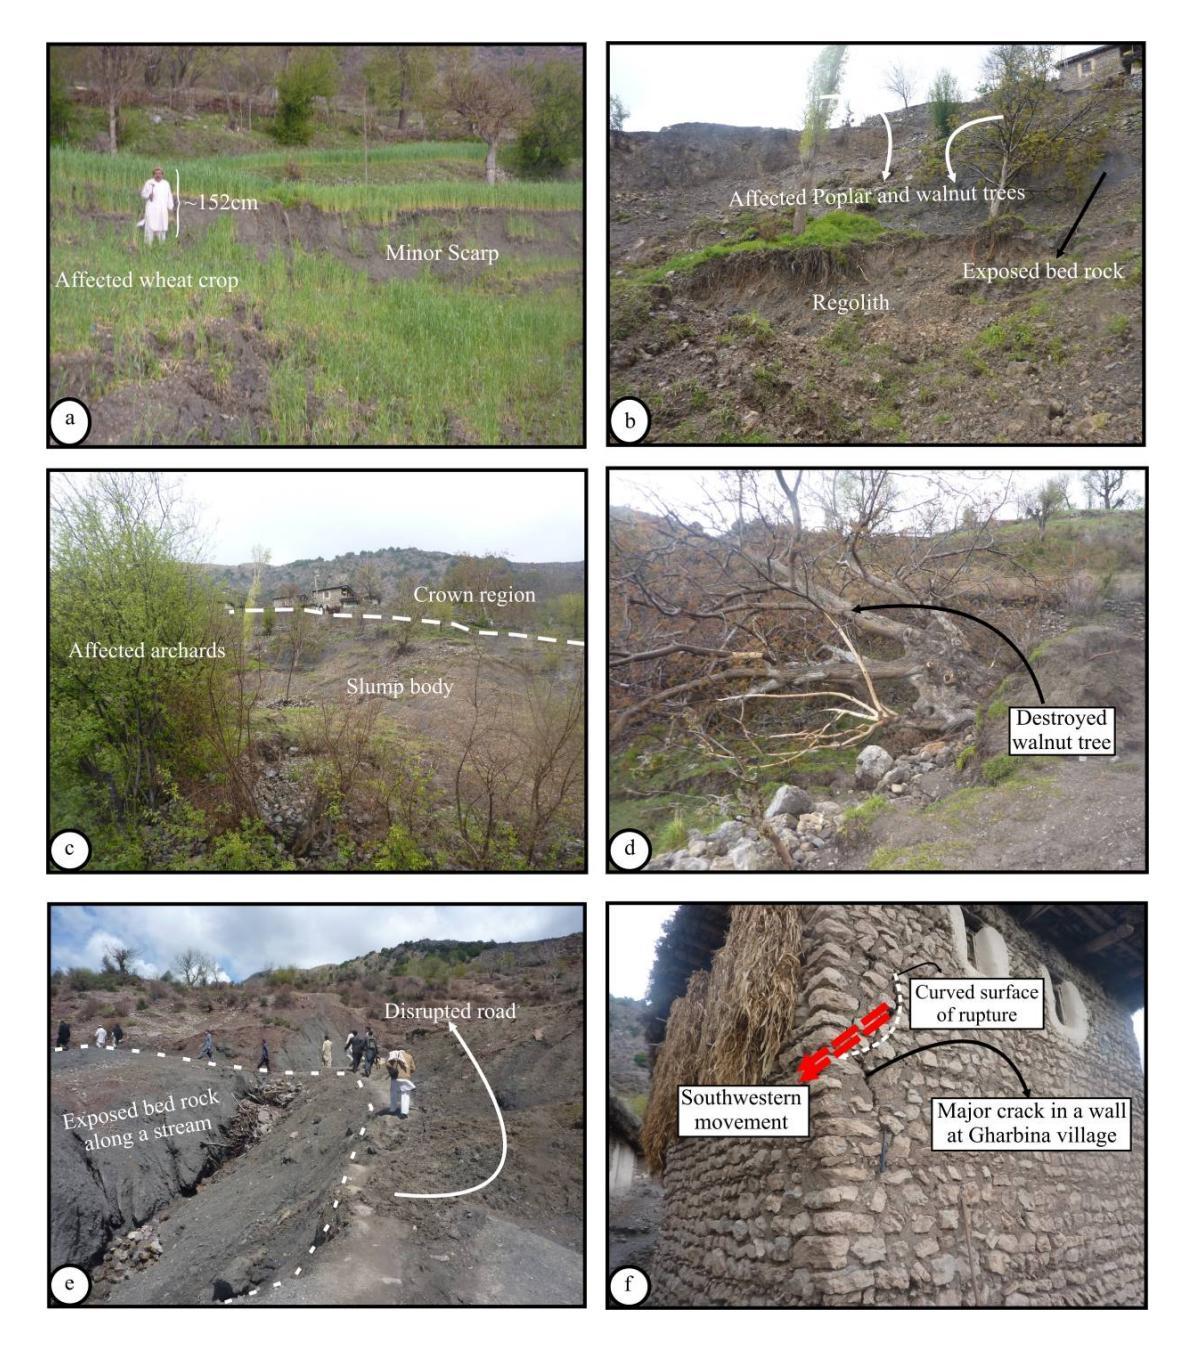
Fig. 3. Photographs showing slump induced destruction at Gharbina village, (a) Part of wheat crop affected during the slump, (b) Backward rotated poplar and walnut trees, (c) Destroyed and uprooted orchard, (d) Entirely uprooted walnut tree, (e) Destroyed community made road. It is the only road in the region, which connects Parachinar city with Gharbina, Khachan, Dand and Rajju villages and (f) Photograph showing cracks within the wall, which is leaned towards southwest at Gharbina Village. These cracks are synchronously developed during the slumping event in the area.

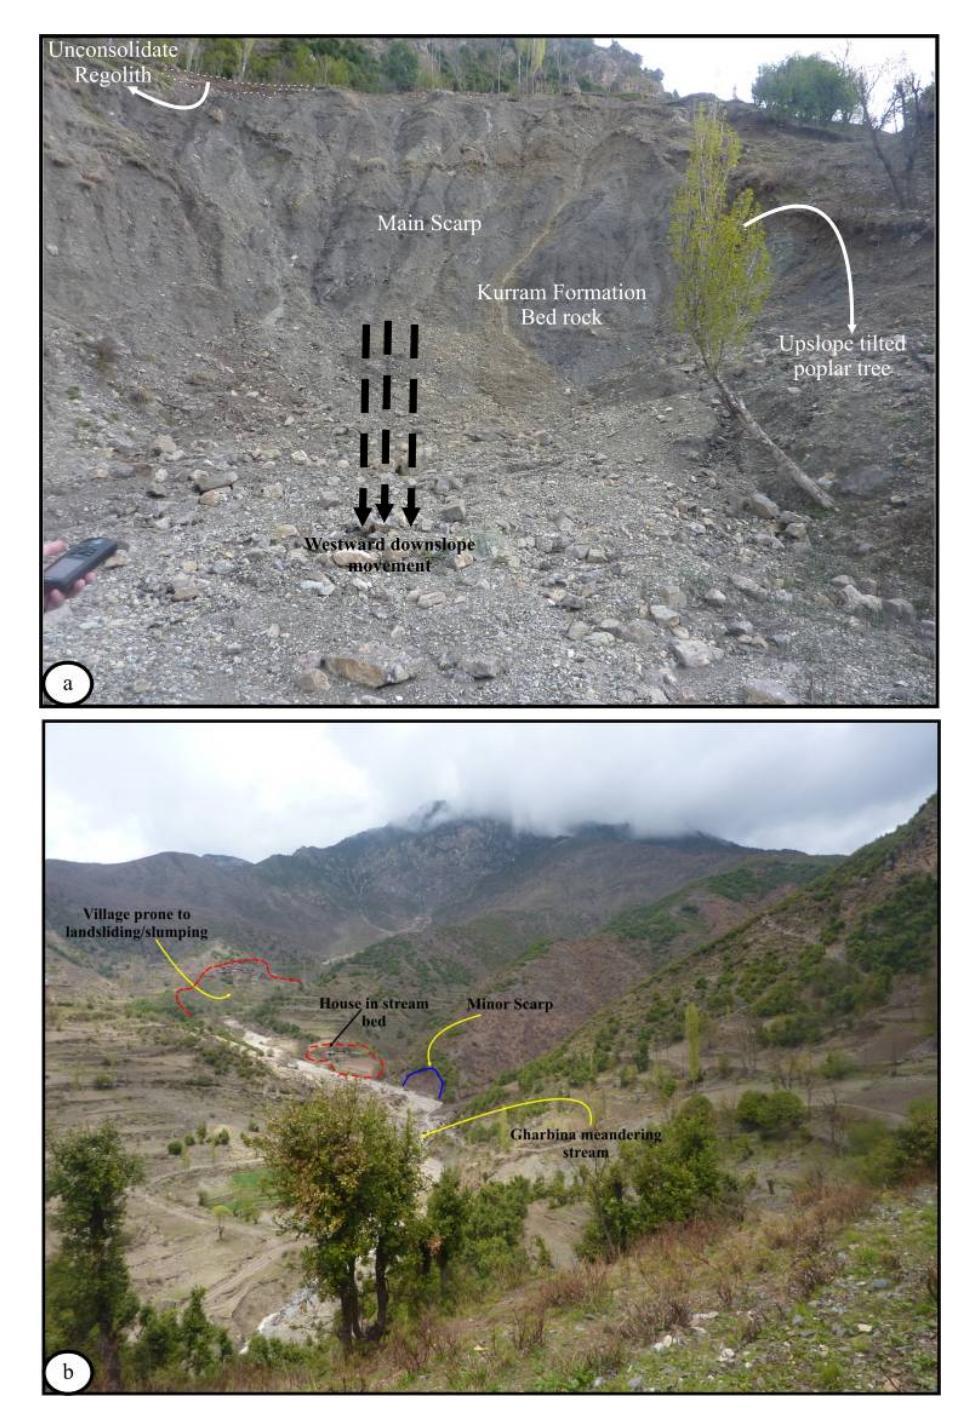
The village is constructed on unconsolidated regolith and underlain by thinly laminated grayish color shale and clay beds of the Cretaceous Kurram Formation/group. These beds are incompetent and highly susceptible to erosion through out the valley. Numerous active slope failures were observed in these clay beds across the region apart from the main Gharbina event (Fig. 4a). The downslope direction of landslides/slumps in the region is dominantly controlled by Gharbina meandering stream. Both sides of the stream are prone to active landslide sites for example showing a minor scarp, mud house constructed in stream bed and a village on landslide prone slope (Fig. 4b).

Fig. 4a) Photograph showing incompetent beds of the Kurram Formation/group susceptible to erosion and mass wasting across the region and (b) Photograph showing meandering nature of the Gharbina stream.

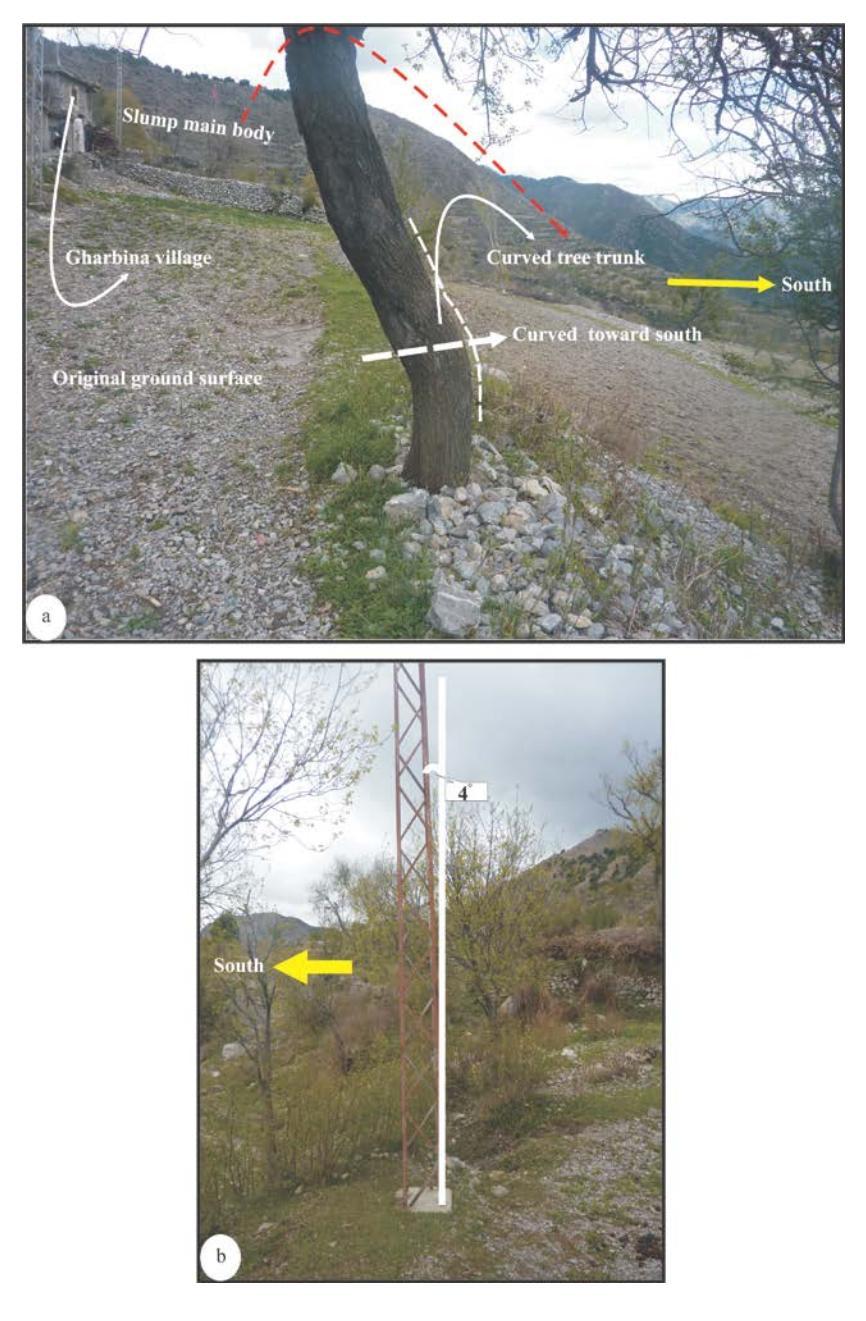
Personal communication with local community indicate that: (a) three houses were damaged by a landslide of the same intensity 40 years ago, (b) high rate of precipitation (torrential rain fall and snow) in the area for the last two years and (c) the whole area and particularly the slopes are characterized by numerous springs. Fortunately this event did not cause any life causalities and injuries so far. A total of 255 people, consisting of 42 families have been residing the affected area in the crown region of the slump. Water-absorption related mass movement is evident in the area in the form of soil creep marked by tilted trees and electric poles (Fig. 5a,b).

Fig. 5. Photographs showing south verging pronounced curves: (a) in a tree trunk and (b) life line, that formed in response to soil creep in the area. Note the creep preceded the slump in the affected area.

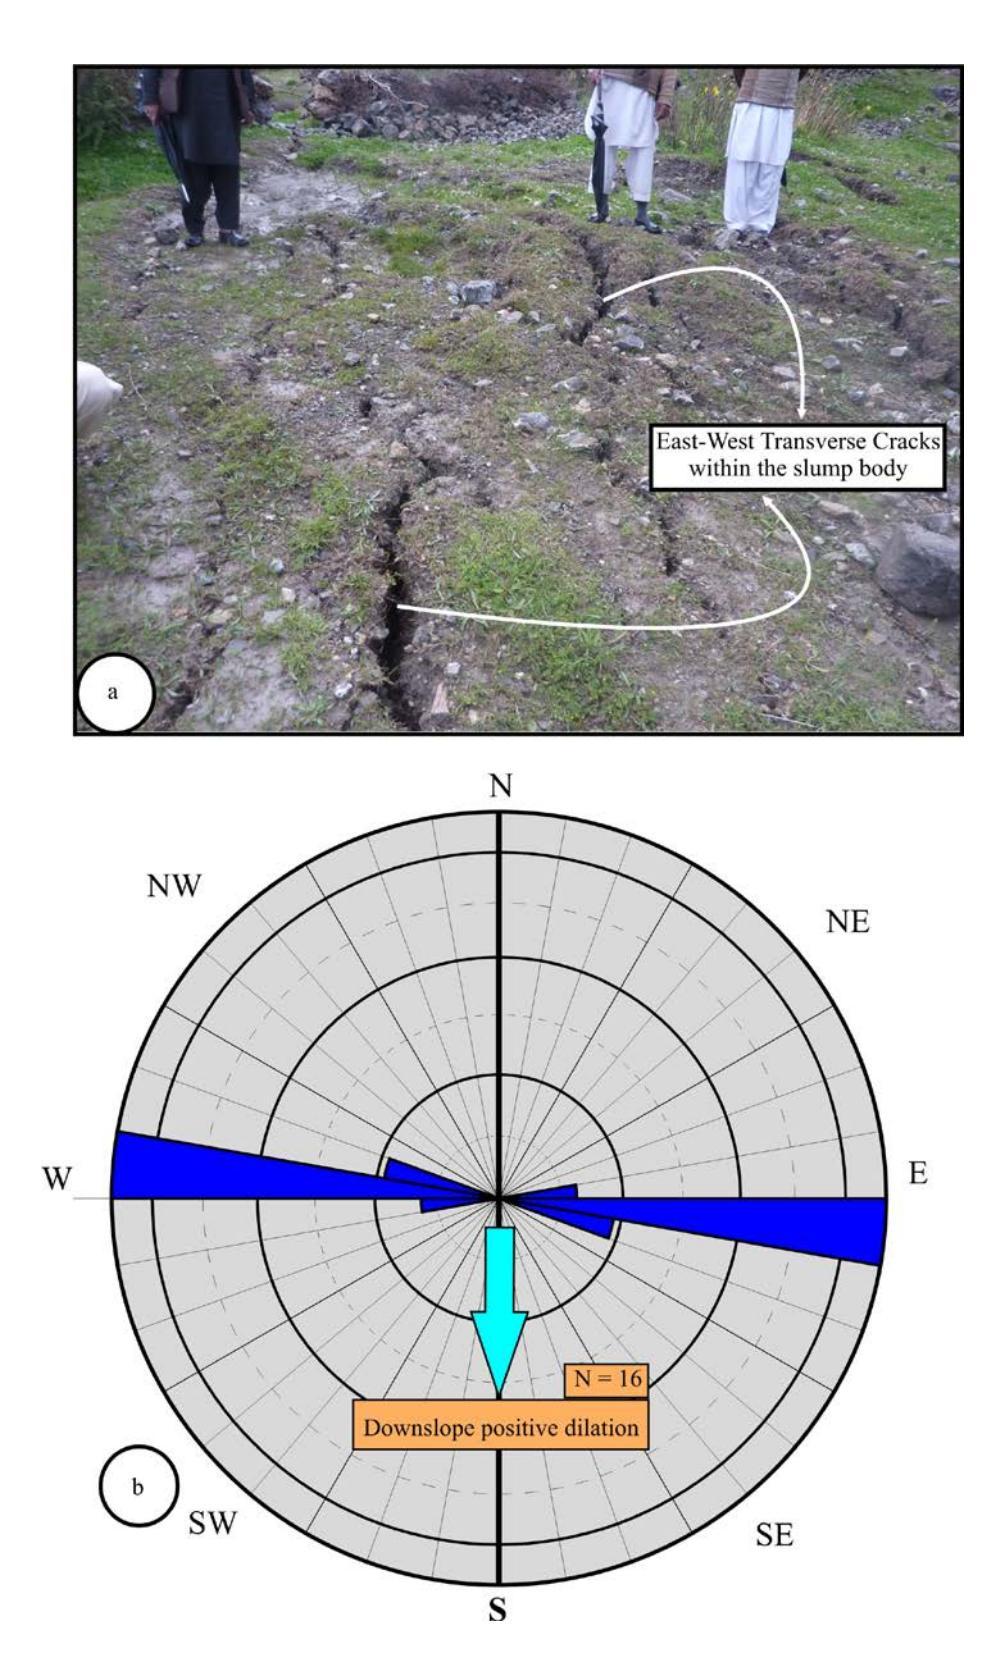
The slumped body is characterized by abundant transverse cracks (Fig. 7a). Trends of these cracks were measured throughout the slumped block (Table 1). They are characterized by irregular surfaces and southward movement. Trends of these cracks were plotted on equal area rose diagram (Fig. 7b). The transverse cracks are east-west trending in the middle part of the slump. However, along the western and eastern walls of the slump the cracks are trending north-south (Fig. 8). These cracks show eastward movement along the western wall and vice versa. The movement due to N-S trending cracks on eastern and western walls is converging toward the main slumped block. The N-S trending cracks at converging point show prominent scarps. Subsequently the main western and eastern walls are characterized by main scarps.

Fig. 7(a) East-West trending transverse cracks measured within the slump and (b) Equal area rose diagram showing trends of the transverse cracks in the slumped body.

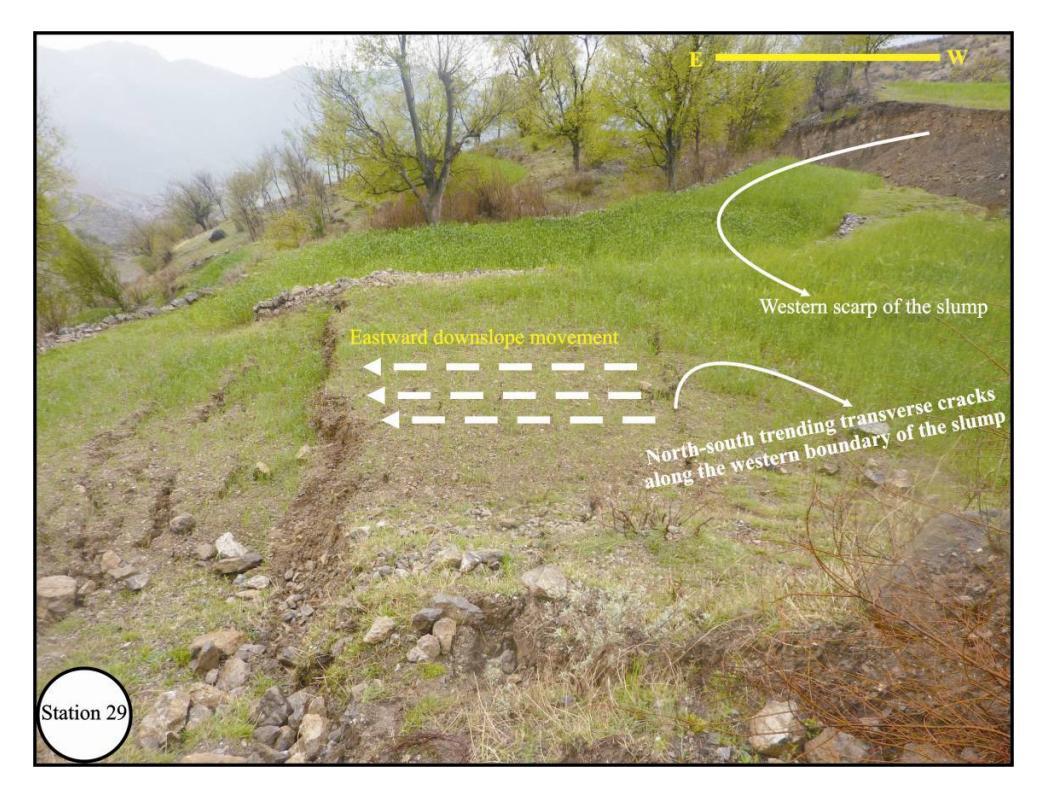
Fig. 8. Photograph showing north-south trending transverse cracks along the western wall of the slump. Cracks along the eastern and western walls indicate westward and eastward movement respectively, enhancing downslope southward motion in the area.

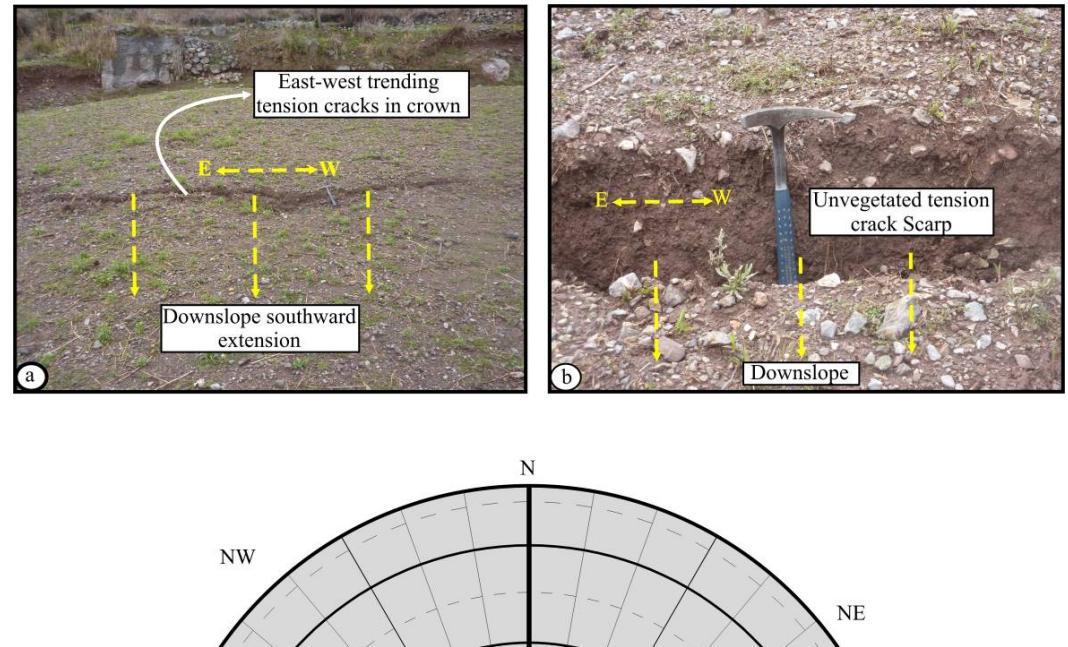
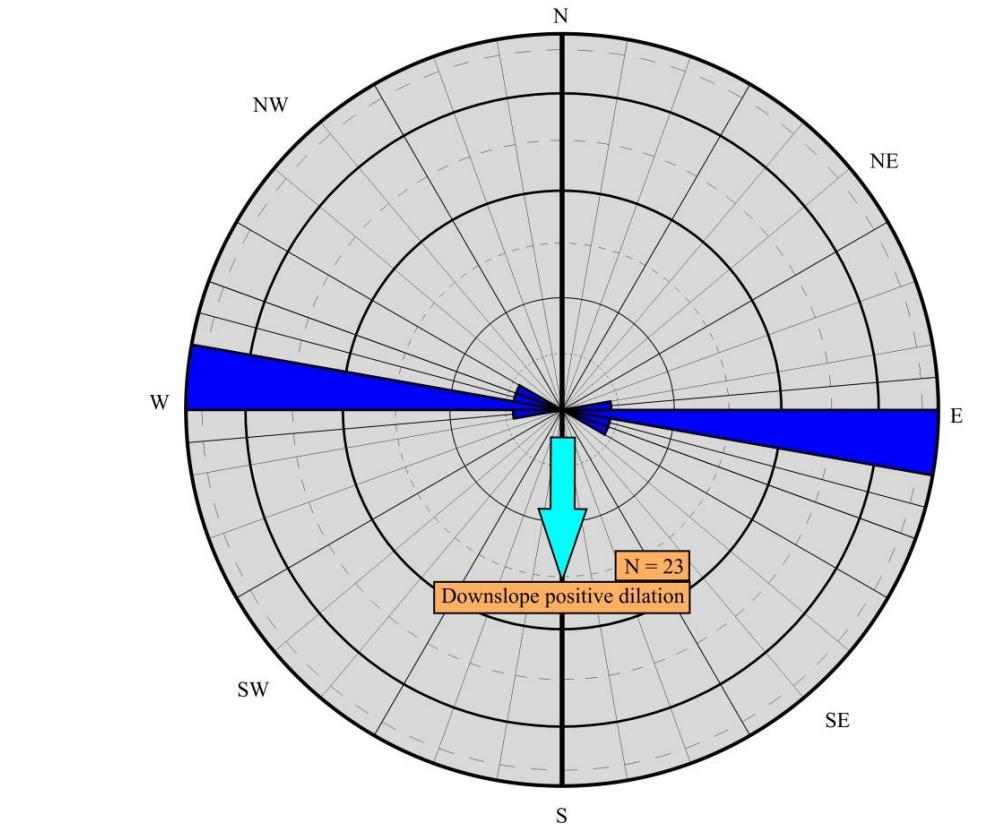
trending (Fig. 9a, Table 2). Trend of these cracks are shown on equal area rose diagram (Fig. 9b). They were observed up-to 300 meters in the north direction of the major scarp. Trend of these cracks become north-south along the eastern and western extremities of the crown. N-S and E-W trending cracks were also observed within the walls of the inhabited area, which seems to be quite dangerous and alarming.

Fig. 9(a) East-West trending tension crack within the crown, (b) This photo indicates the downslope movement and depth of the tension crack. The arrows showing southward downslope motion of the ground and (c) Equal area rose diagram showing the trends of the tension cracks in the crown.

- 1. The residential area, which is struck by slump, and has been evacuated, should be maintained as such till engineering measures are taken and the area is stabilized.
- 2. The tension cracks in the crown region and map slump should be sealed so that water from rain, irrigation and snow cannot infiltrate.

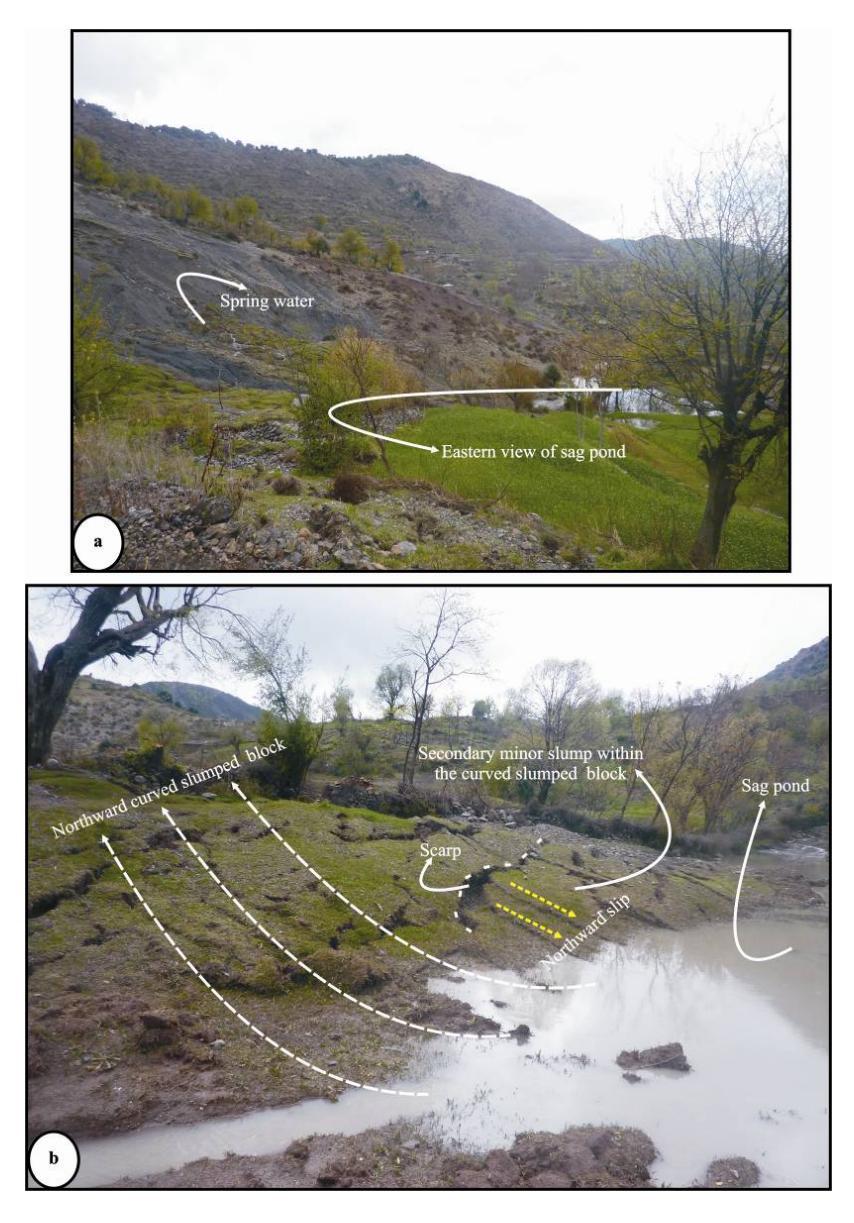
Fig. 10(a) Eastern view of the main sag pond and (b) Photograph showing sag pond, collecting rain and spring water. The northward motion of the slumped block is due to the curving rupture surface. Secondary slumps postdate the main slumping event.

The incompetent shale and clay beds of the Kurram Formation/group are highly susceptible to slumps and earth flow if they soak up water during heavy rains or snow falls. This was inferred because majority of slumping in the region are closely associated with these incompetent shale and clay beds of the Kurram Formation/group covered by unconsolidated regolith. Sag ponds, which are developed from the northward rotation of the leading edges of the slump materials within the main slump block, are filled with water from seepages and heavy rainfalls (Fig.10). The accumulation of water in sag ponds can exert

pressure on the confining walls, which can potentially accelerate down slope movement of the entire slumped block. The gap between the scarp and rotated slumped block in future can aggravate the situation by getting activated along the tension cracks in the crown and main slump regions after deep water percolation along these cracks (Fig. 9a, b). Southward downslope movement within the crown region has already been observed, which is alarming. The major cause of the slump and earth flow in the investigated area is because of water saturation in the regolith, Gharbina meandering stream and the underlying incompetent rocks of the Kurram Formation/group. Apart from the Gharbina village, other active landslides in the region are closely associated with these unconsolidated and incompetent slope materials plus Gharbina meandering stream (Fig. 4b). Additionally this region is extremely susceptible to Landsliding because it endures heavy rains during summer and heavy snow falls during winter, which further adds enormous weight to slope materials. Highly landslide prone region in the vicinity of Gharbina village is shown in Figure 11. Apart from Gharbina villages other villages in the valley named Khachan, Dand and Rajju, which are built on unconsolidated regolith and thinly laminated shale and clay beds of the Kurram Formation/group, need further geological and engineering measures to assess and mitigate future landslides in the region.

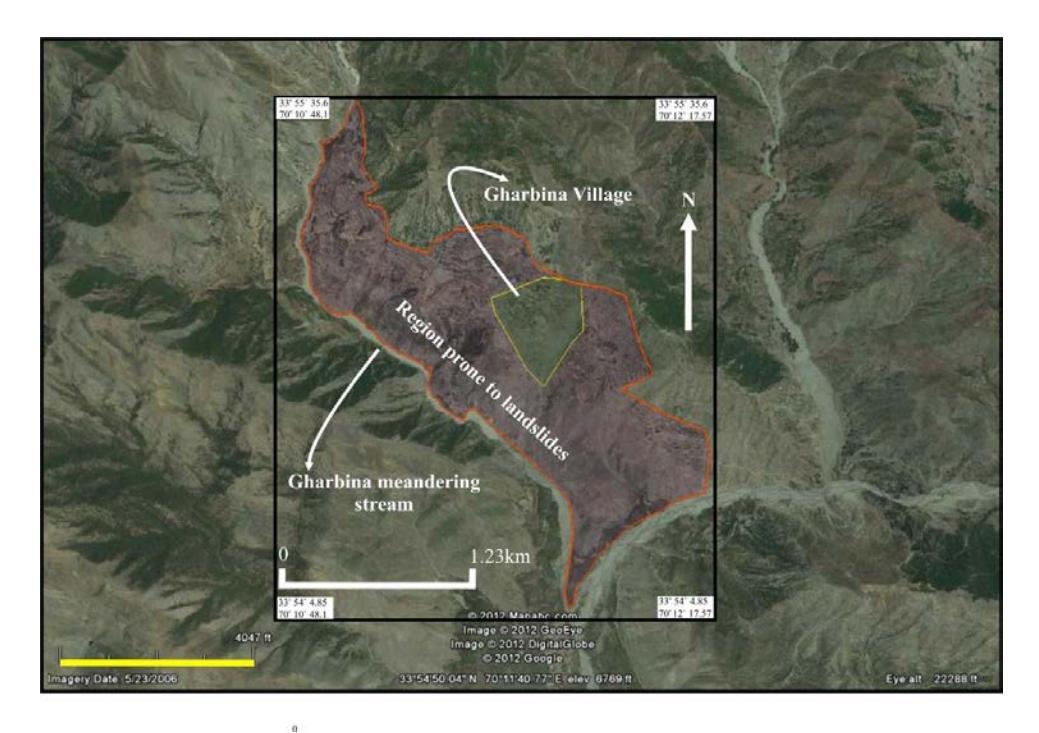
Fig. 11. Satellite map showing location of the region prone to future landslides. Note the landslide prone area is absolutely lacking forestation.

- 5. Any further excavation which might facilitate movement along slopes should be prohibited in the area shown in the Figure 11.
- 6. Forest cover is important in stabilizing slopes and protecting land from degradation. Therefore a campaign in the area against deforestation may be initiated to avoid incidents like this to happen in future.

- 9. Retaining walls at the toe of south and southwest dipping slopes (Fig. 11) can provide exceptional support to stop Gharbina meandering stream bank failure.
