Moenjodaro: A World Heritage Site at Risk

Muhammad Safdar Khan

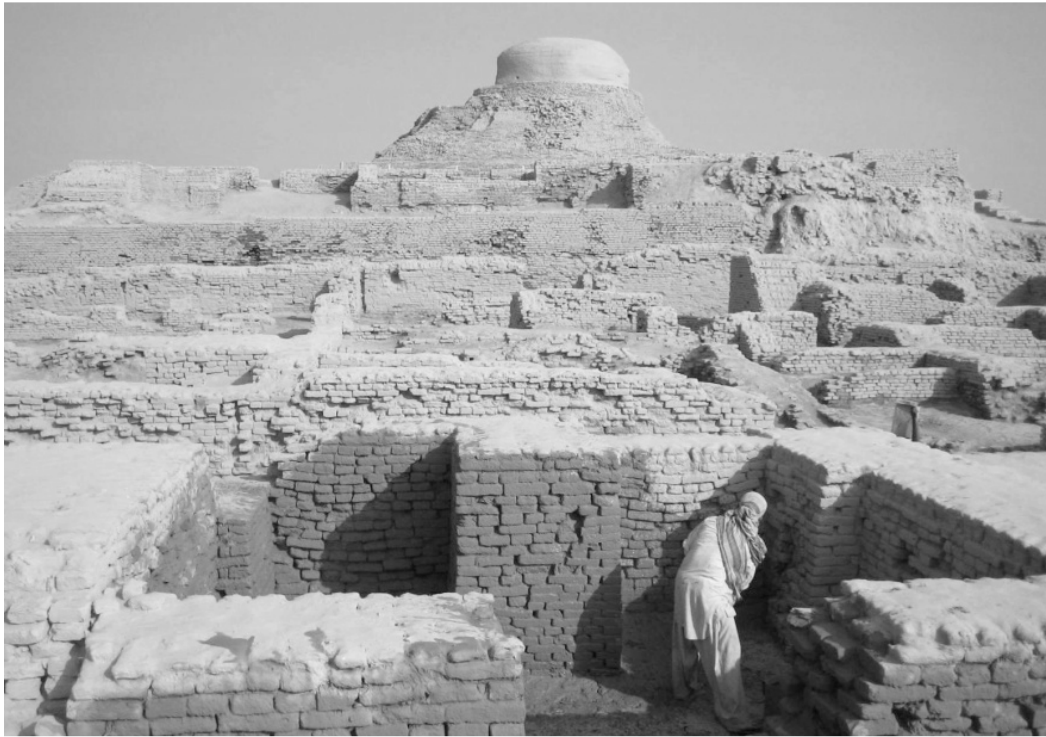
Figure 1: Moenjodaro, View of the SD area with mud brick stupa in the background.

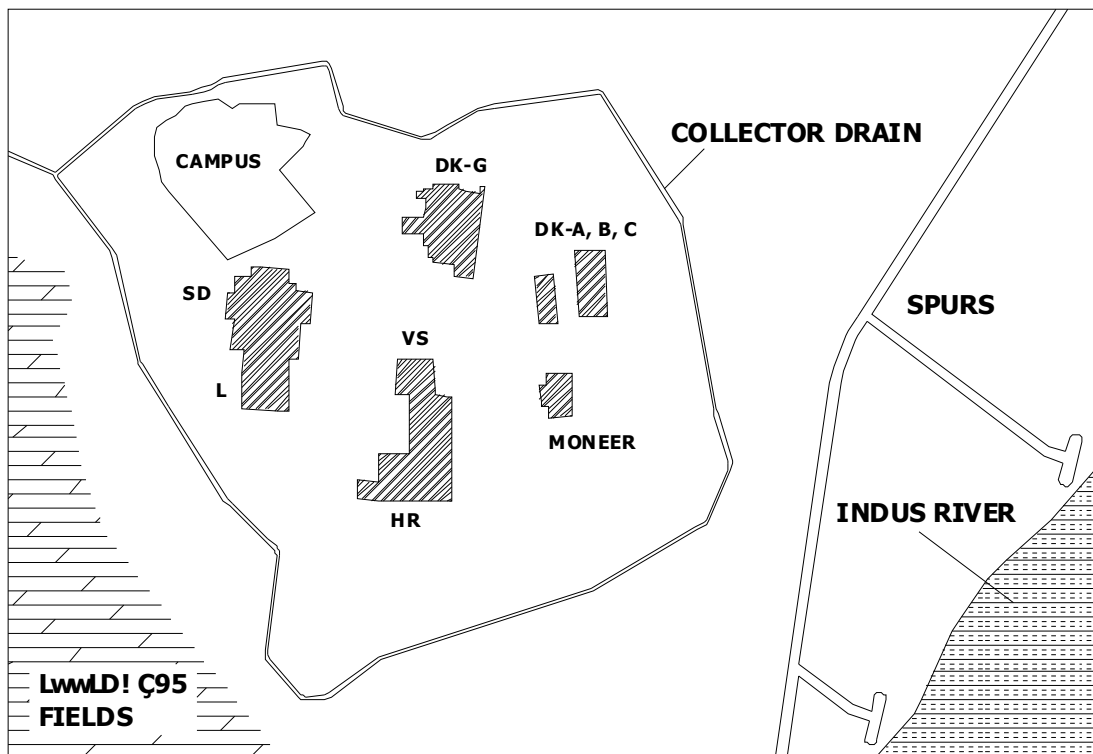
- iv. The agricultural land around Moenjodaro has high salts content and this is increased by the irrigation system: fields are inundated with water for weeks and this makes the water table rise (see Figure 2 for proximity of fields to the site). As a result water tends to migrate towards the structures and salts crystallize on the surface. There is an urgent need to stop the cultivation of paddy crops to overcome the problem.

Figure 2: Schematic plan of Moenjodaro with extent of excavated areas.
