# Landslide hazard zonation map of Kurram Valley: A case study of landslide at Gharbina village, Parachinar, Kurram Valley

### Abstract

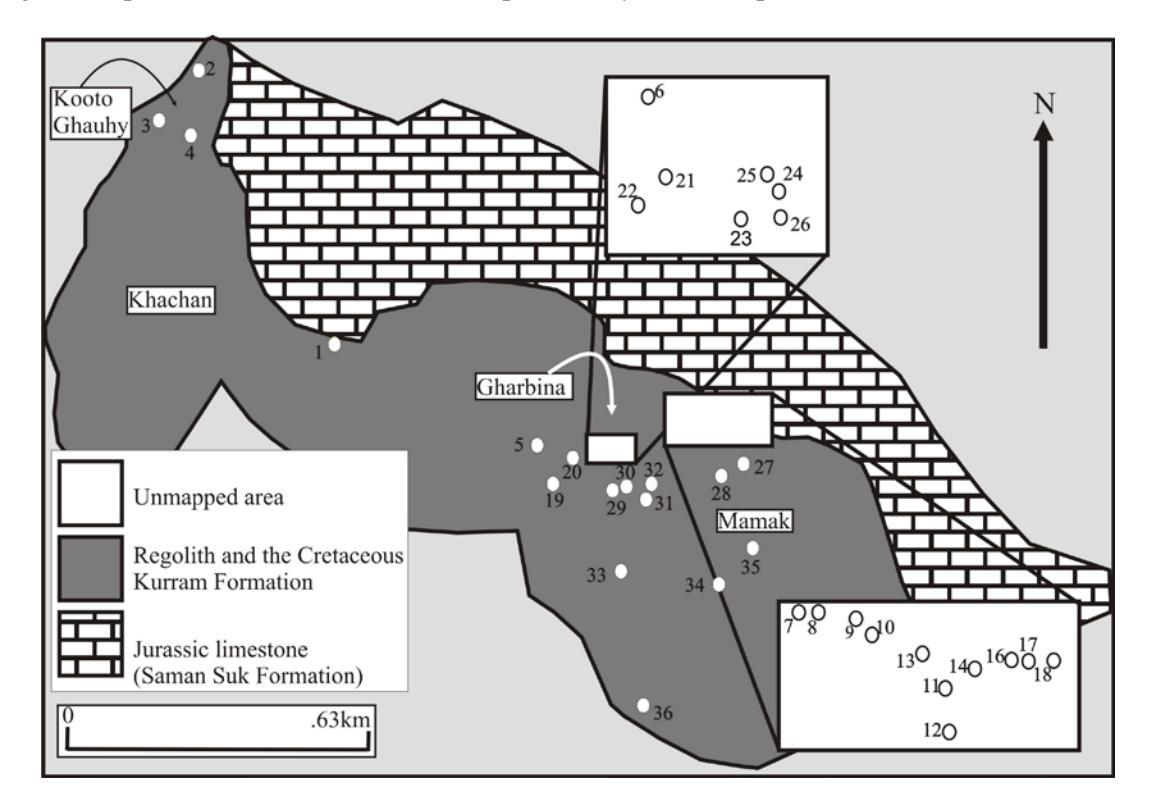
The conventional geological mapping techniques aided by enhanced image analyses of the satellite images are used for constructing the geological map of the affected area. The map is based on the field classification of lithologies (Fig. 6).

Fig. 6. Simplified geological map of the study area. White circles showing location of study stations.
